Geotechnical Investigation

Micron Property – Highland Emerald and Single Family

Approximately 500 West and State Road 92
Lehi, Utah

GeoStrata Job No. 589-100

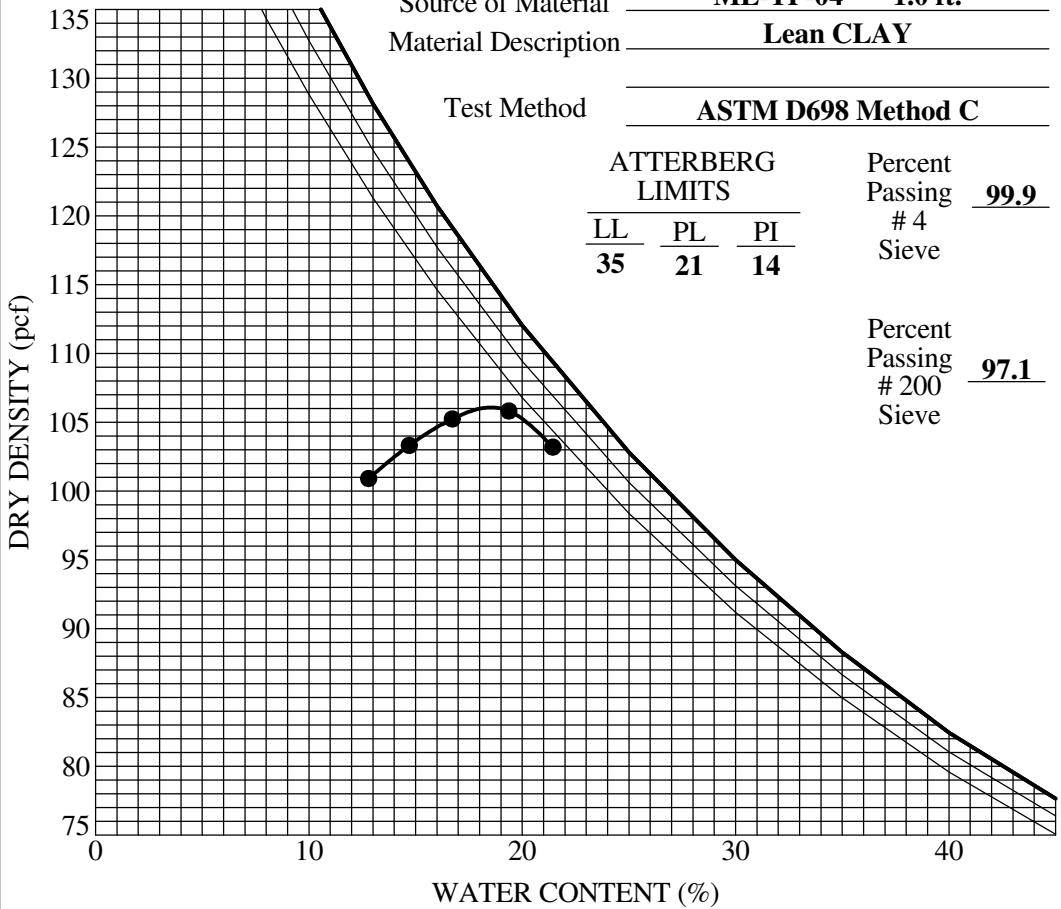
Plate
C - 22

TEST RESULTS	
Maximum Dry Density	<u>107.0 (pcf)</u>
Optimum Water Content	<u>18.5 (%)</u>
Percent Rock	_____ (%)
Corrected Maximum Dry Density	_____ (pcf)
Corrected Optimum Water Content	_____ (%)

California Bearing Ratio - ASTM D 1883

COMPACTION AND CBR TEST
